**NASA CONTRACTOR  
REPORT**

NASA CR-2122

**ANALYTICAL AND EXPERIMENTAL INVESTIGATION  
OF AIRCRAFT METAL STRUCTURES  
REINFORCED WITH FILAMENTARY COMPOSITES  
Phase III - Major Component Development**

*Prepared by  
BOEING COMMERCIAL AIRPLANE COMPANY  
Seattle, Wash. 98124  
for Langley Research Center*

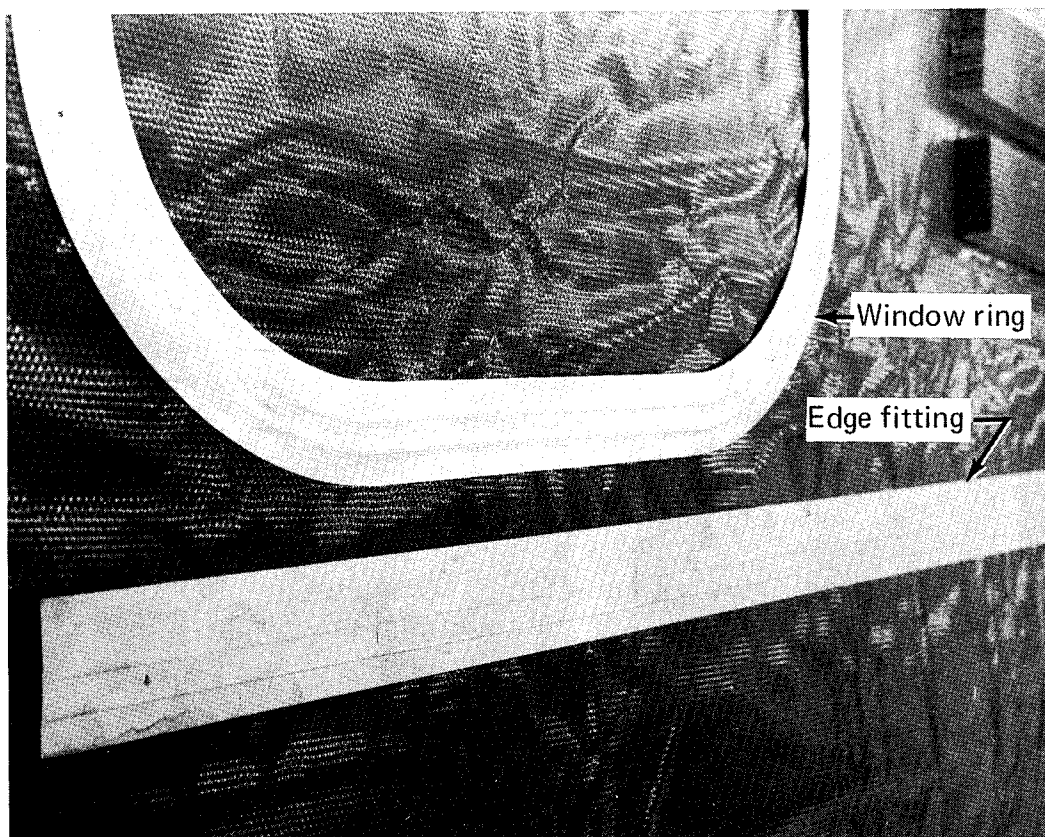
FIGURE C-8.—CHEMICALLY MILLED TITANIUM LOAD TRANSFER FITTINGS
